Underrated danger  
**intercrystalline corrosion**

**the corrosion test in comparison**

# The corrosion test in comparison

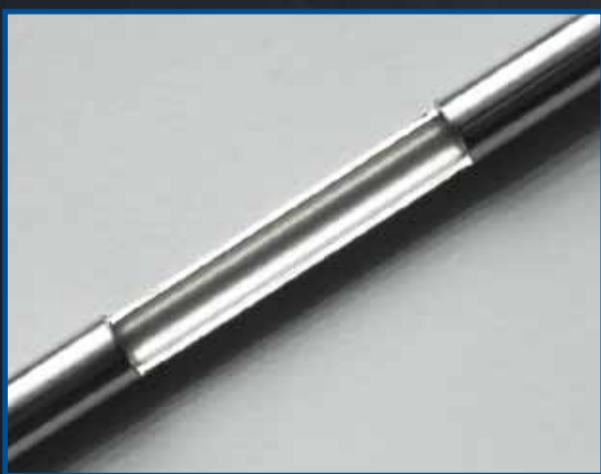
Initial tube:  
**Tube in excellent TPS quality**

Delivery condition solution annealed (bright annealed)

Material grade: 1.4306

Dimension: 10,00 x 1,50 mm

On both initial tubes, a Huey test (corrosion test) was performed. The changing of the inside surface was documented step by step by means of scanning electron microscope pictures in 500-fold magnification (see back).

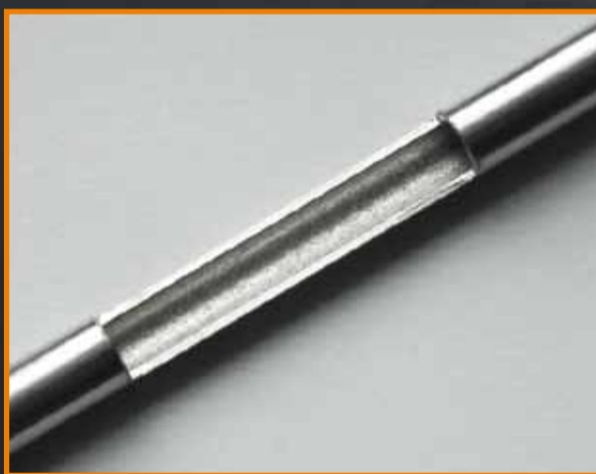
Initial tube:  
**Tube with intercrystalline corrosion attack**

Solution annealed (bright annealed) with intercrystalline corrosion on the inside surface

Material grade: 1.4306

Dimension: 10,00 x 1,50 mm

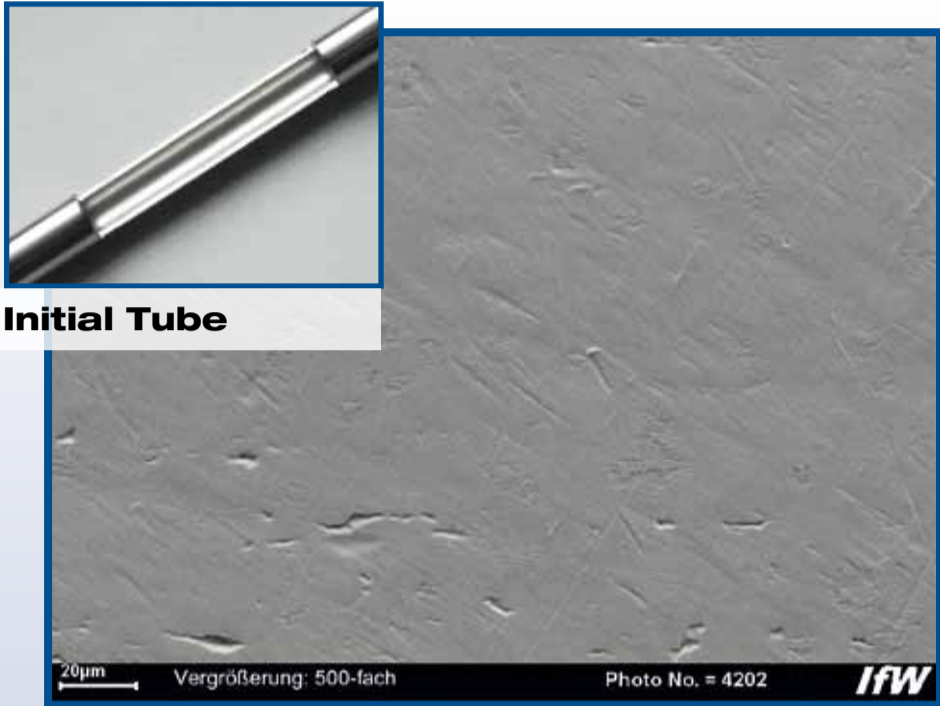
Initial Tube

1. Inside surface **without** intercrystalline corrosion on the initial tube (delivery condition)  
Inside roughness:  $<Ra\ 0,5\ \mu m$   
Magnification: 500-fold

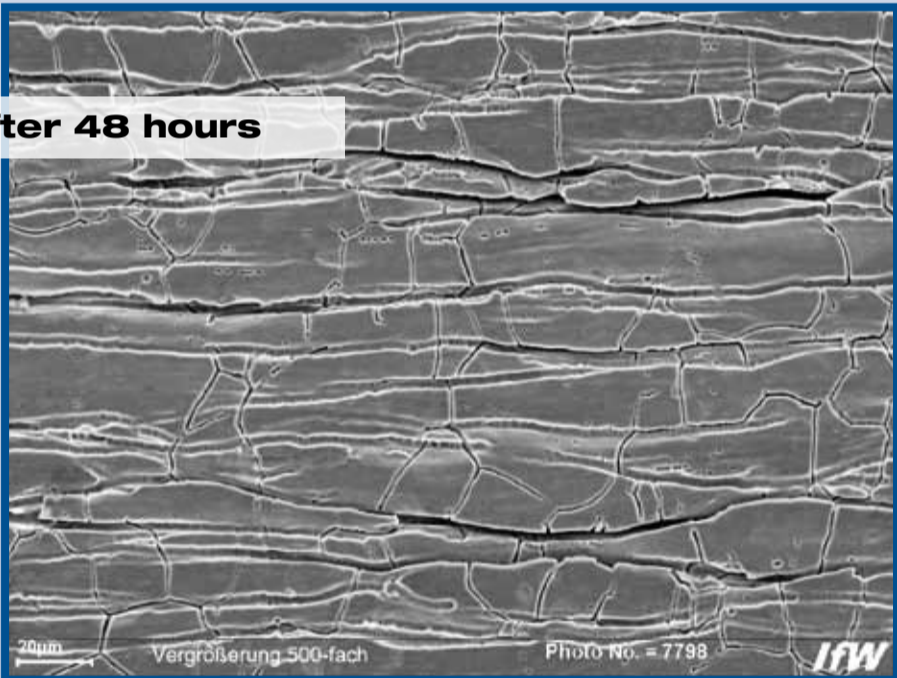
after 48 hours

2. Inside surface **without** intercrystalline corrosion on the initial tube after Huey test, 1st cycle (after 48 hours)  
Mass loss rate:  $0,33\ g/m^2\ x\ h$   
Magnification: 500-fold

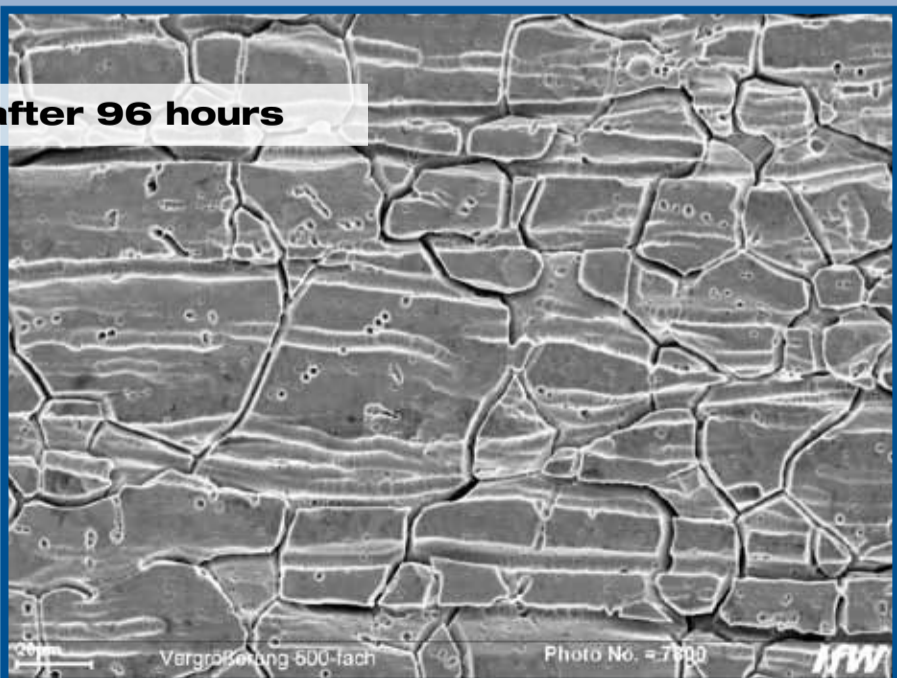
after 96 hours

3. Inside surface **without** intercrystalline corrosion on the initial tube after Huey test, 2nd cycle (after 96 hours)  
Mass loss rate:  $0,33\ g/m^2\ x\ h$   
Magnification: 500-fold

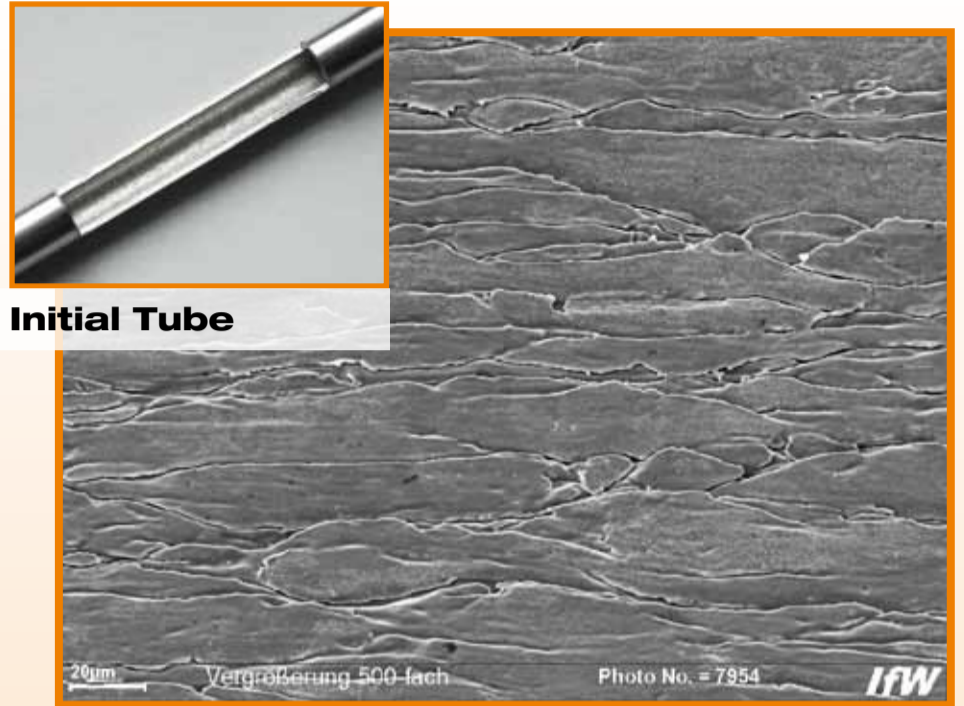
Initial Tube

1. Inside surface **with** intercrystalline corrosion on the initial tube  
Inside roughness:  $>Ra\ 1,5\ \mu m$   
Magnification: 500-fold

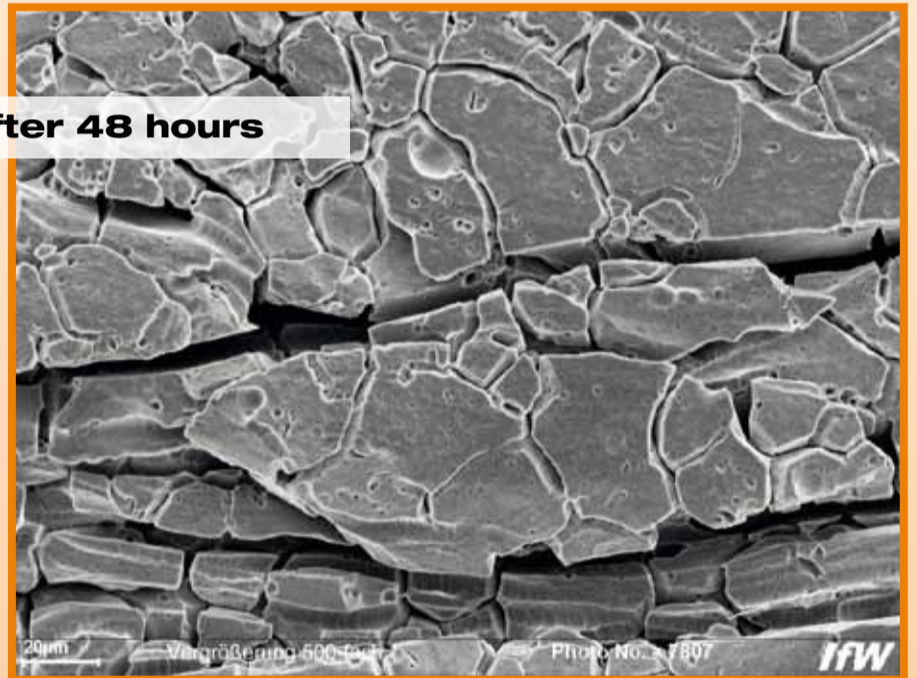
after 48 hours

2. Inside surface **with** intercrystalline corrosion on the initial tube after Huey test, 1st cycle (after 48 hours)  
Mass loss rate:  $1,65\ g/m^2\ x\ h$   
Magnification: 500-fold

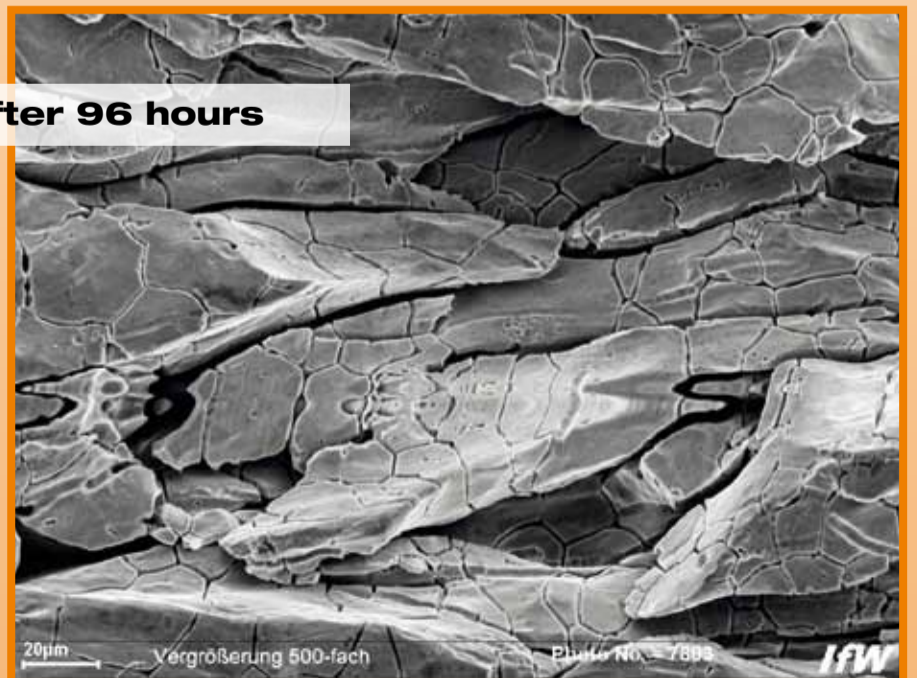
after 96 hours

3. Inside surface **with** intercrystalline corrosion on the initial tube after Huey test, 2nd cycle (after 96 hours)  
Mass loss rate:  $1,3\ g/m^2\ x\ h$   
Magnification: 500-fold
