TPS Multiseal

Recommendations for Field Inspection and Repair of TPS Multiseal Premium Connections

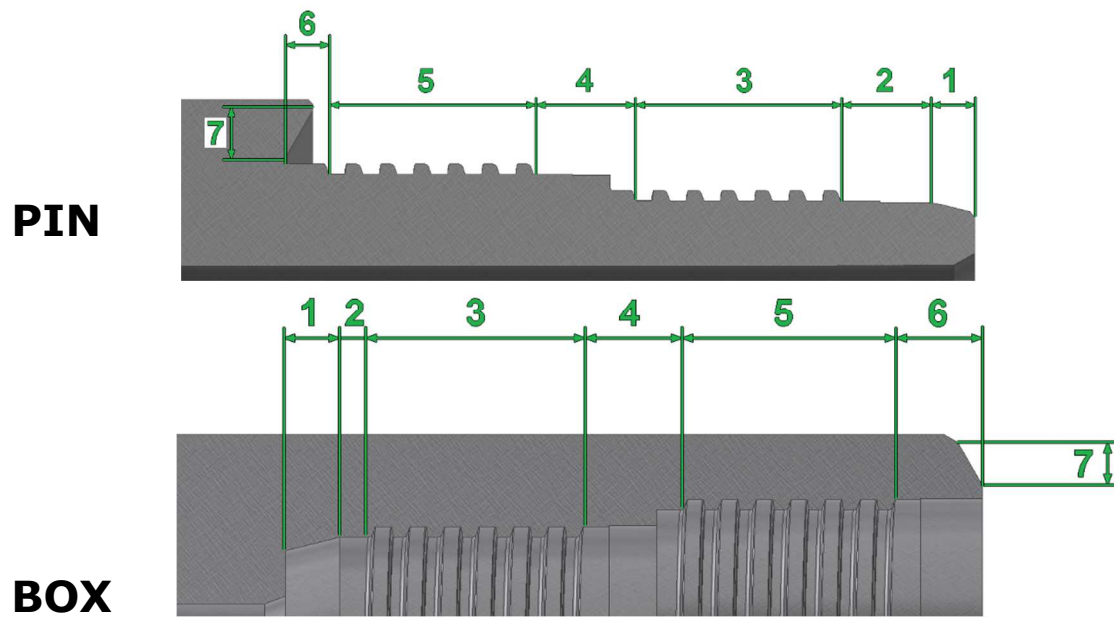
10.Attachment 1

Pin & Box End element	Zone	Rust / friction marks	Pitting	Dent	Scratch	Galling
14° Seal shoulder	1	Re-cut the thread (1)	Re-cut the thread (1)	Re-cut the thread (1)	Re-cut the thread (1)	Re-cut the connection
cylindrical section	2	remove to smooth surface (1)	remove to smooth surface (1)	remove to smooth surface (1)	remove to smooth surface (1)	Re-cut the connection (1)
thread	3	remove to smooth surface	remove to smooth surface (1)	remove to smooth surface	remove to smooth surface (1)	Re-cut the connection (1)
cylindrical section	4	remove to smooth surface (1)	remove to smooth surface (1)	remove to smooth surface (1)	remove to smooth surface (1)	Re-cut the connection (1)
thread	5	remove to smooth surface	remove to smooth surface (1)	remove to smooth surface	remove to smooth surface (1)	Re-cut the connection (1)
cylindrical section	6	remove to smooth surface (1)	remove to smooth surface (1)	remove to smooth surface (1)	remove to smooth surface (1)	Re-cut the connection (1)

30° Seal & torque shoulder	7	remove to smooth surface (1)	remove to smooth surface (1)	remove to smooth surface (1)	remove to smooth surface (1)	Re-cut the connection

(1) Minor imperfections may be accepted by a connection specialist or can be removed with abrasive fleece/emery paper. Repair is only allowed if it is performed by an Inspector / Specialist.

Perform the repair work in accordance to Attachement 1
